# Manhole Inspection Summary

Manhole # S15AA\_004MH

Insp Date: **5/6/09 1:33 PM**

**Location** Address: **2606 LAFAYETTE AVE**

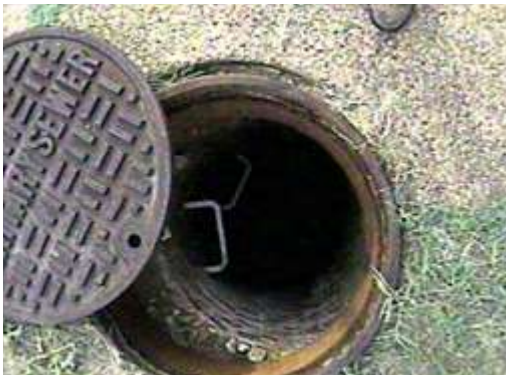
Defect 3

Offset: **5** (in.)

FRAME OFFSET

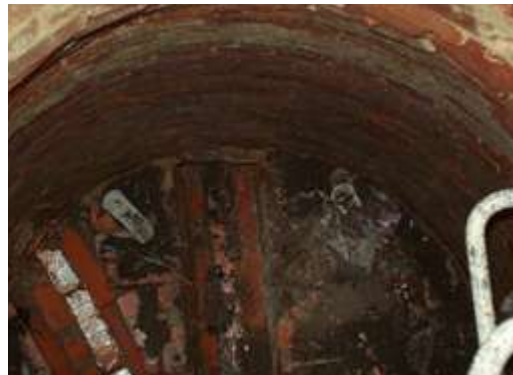
Defect 1

☒ **Evidence Of Surcharge** Depth: **3** (ft.) ☐ Active Surcharge Present

EVIDENCE OF SURCHARGE

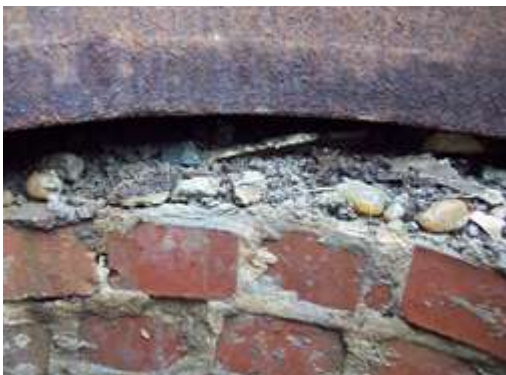
Defect 2

Condition: ☐ Sound ☐ Cracked ☐ Root Intrusion ☐ Loose Brick ☒ **Deteriorated**

CHIMNEY DETERIATION

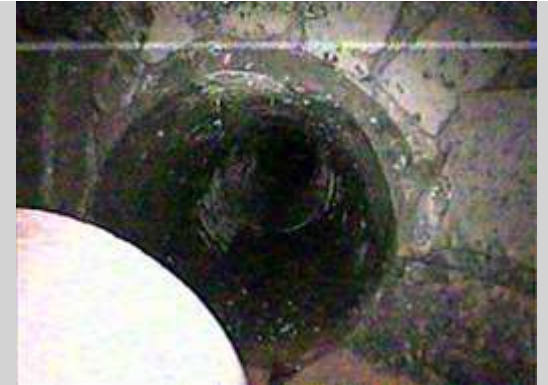
12 O'Clock Outflow

8 in. Circular Gravity Sewer  
Pipe Out @ 12 O'Clock

Infiltration: **None** Pipe Seal Cond: **Sound**

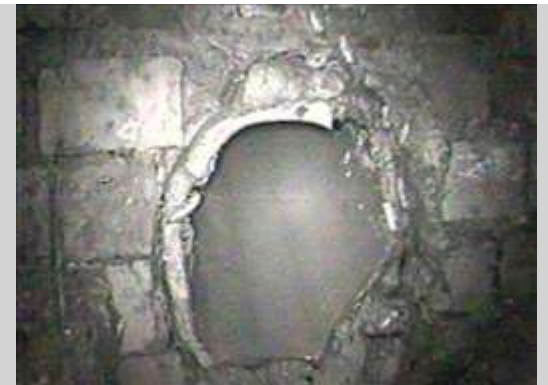
5 O'Clock Inflow

8 in. Circular Gravity Sewer  
Pipe In @ 5 O'Clock

Infiltration: **None** Pipe Seal Cond: **Broken**

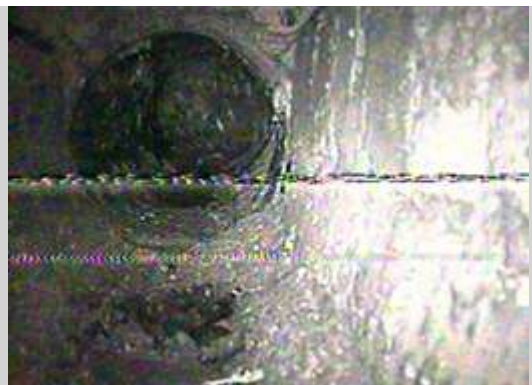
6 O'Clock Inflow

8 in. Circular Gravity Sewer

Pipe In @ 6 O'Clock

Pipe Seal Cond: **Unknown**
